# BELZONA SOLVES DREDGE PUMP WOES

Dredge pump repair.

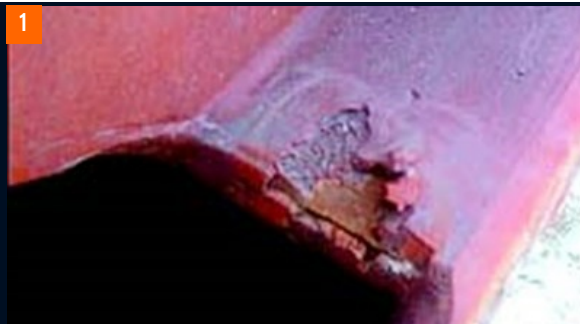
Large roots and stones damaged cutwater and stripped rubber coating from pump.

1. The damage
2. Completed repair
3. Dredge pump ready for service
