# PROTECTION OF ACID HOLDING TANK WITH BELZONA

ID: 401

Exterior protection of acid holding tank.

Nitrogen Plant - Mexico

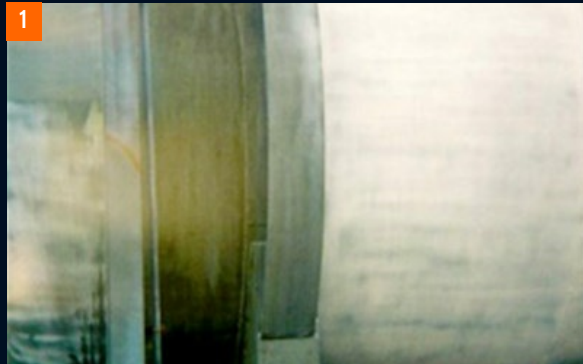
Failure of existing external coating due to the surrounding environment conditions.

1. Corrosion damage on the side of the tank.
2. Overall condition of the tank before application of the Belzona coating system.
3. Coating application is complete. The system consists of two coats of both the Belzona 6111 and Belzona 5111.
