# ROOF PENETRATION PROBLEM SOLVED WITH BELZONA

ID: 4022

20 year roof of a chemical manufacturer

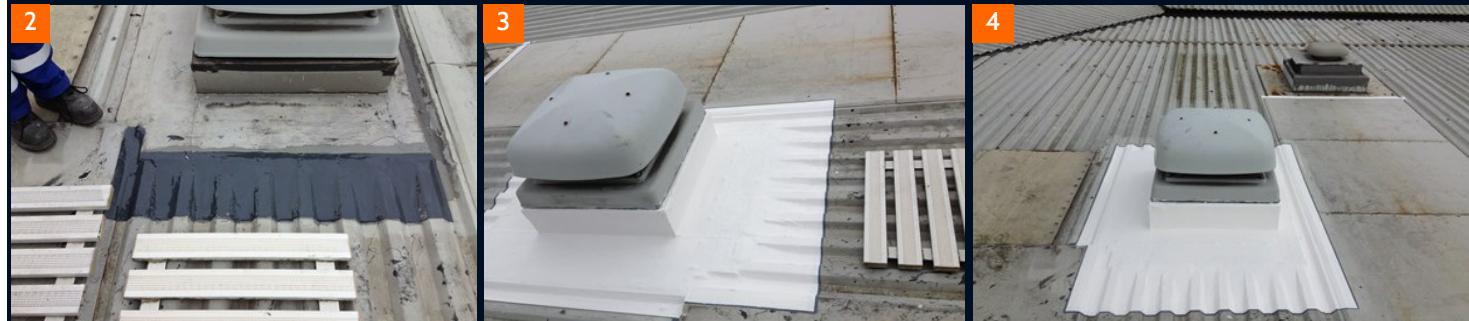
## PHOTOS

An extraction vent had created a leak at its penetration which could create a slip problem in the factory below

1. Problem area
2. Belzona elastomer used to prevent standing water
3. Completed repair
4. Completed repair

The application was carried out in accordance with RPA-1. The problem had been made worse by standing water in the troughs, which had caused the existing seal to have to work harder. The Belzona Consultant included as part of the repair, the use of Belzona elastomers (due to the flexing of the roof) to allow the water to shed effectively.
