# BELZONA REPAIRS DAMAGED PRE-HEATER FAN SHAFT

ID: 4024

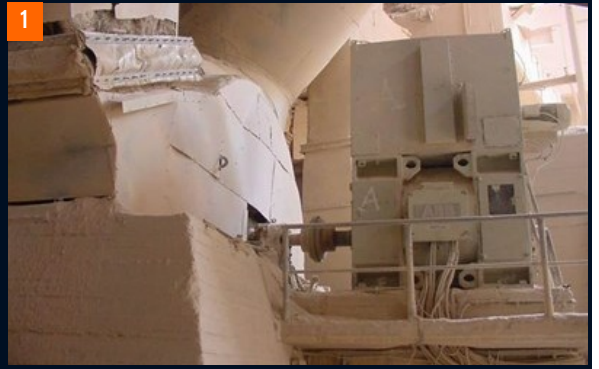
The shaft was worn out under the bearing.

1. The damaged equipment
2. The damaged area
3. The application before removal of formers
4. The completed application

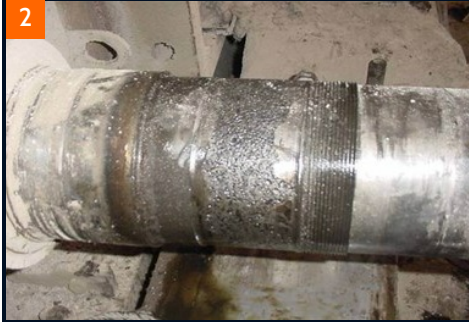
Worn shaft
