# BELZONA PROTECTS CRUDE OIL STORAGE TANK

ID: 403

Exterior coating of 1000-barrel crude oil storage tank.

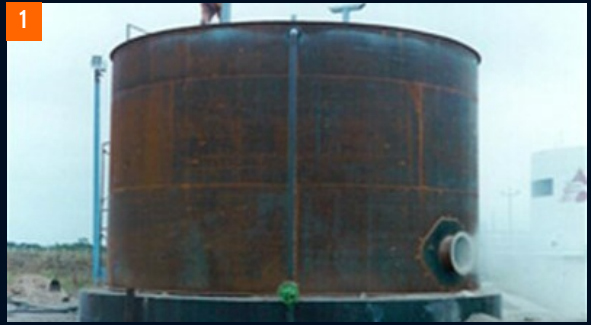
Due to the tank farm's proximity to the coast, a host of components, including abrasion from the sand, salt air, contamination from residual sour gas and other chemical components, contributed to the accelerated erosion/corrosion of the exterior of the storage tank.

1. Overall condition of the tank before the application of the Belzona coating system.
2. Grit blasting taking place.
3. Application of Belzona 6111 using spray equipment.
4. View of the tank once the Belzona coating system had been applied.
