# BELZONA REPAIRS AND PROTECTS RUDDER STOCK

ID: 4038

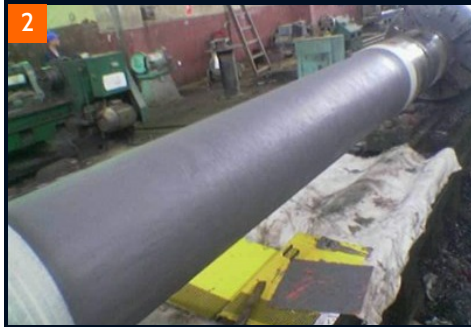
Ships rudder stock was suffering from the effects of erosion-corrosion

1. Corrosion-erosion damage.
2. Belzona 1111 successfully applied
3. Belzona 1321 successfully applied
4. Back in service after repair completion

This repair was carried out in accordance with MPT-1. The damaged area was rebuilt using Belzona 1111 (Supermetal) before the area was protected from further damage with Belzona 1321 (Ceramic S-Metal).
