# BELZONA CAPITALIZES ON COALESCER

Electrostatic Coalescer.

Oil/Gas Producer - Venezuela

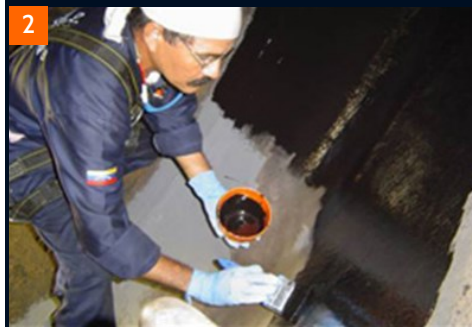
Microbiologically-induced corrosion (MIC) had severely affected portions of this vessel.

1. Extent of the corrosion due to the effects of the microbiological attack.
2. View of the application underway. Belzona 1121 and Belzona 5891 were used.
3. Final view of the entire bottom portion of the vessel that was treated.
4. Exterior view of the coalescer.

As the damage to the vessel was well defined, only the bottom portion of the vessel was treated. Careful surface preparation was implemented as the microbiological impact over the metal was extensive. Detection tests to confirm microorganisms made it a necessity to carefully clean and prepare the metal surface. Ultimately, the Belzona® 1121 was used to rebuild the corroded areas, followed by Belzona® 5891 as the coating material.
