# BELZONA REBUILDS DAMAGED DECK FLOOR

ID: 4040

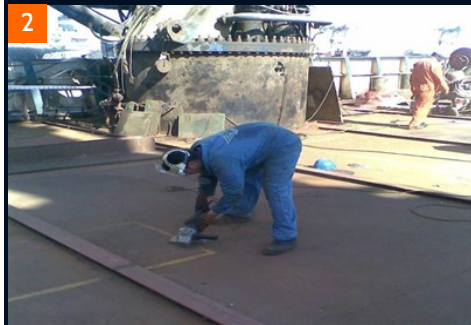
Severe pitting corrosion had occurred on the deck floor which needed rebuilding.

1. Damaged Area
2. Surface Preparation
3. Belzona 1121 application
4. Completed application

This was carried out using a modified version of FPA-1. After surface preparation the Belzona 1121 could be applied to restore the deck to its original dimensions.
