# BELZONA PROVIDES INTERNAL CORROSIVE RESISTANT LINING

ID: 4041

Media filter requiring internal lining

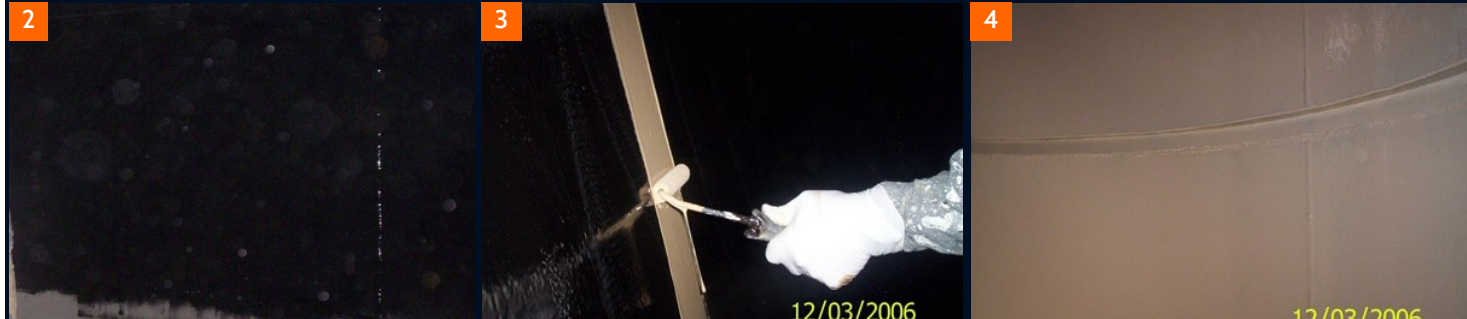
Corrosion occurring on the internal surfaces which needed to be protected.

1. Corrosion Damage
2. 1st coat successfully applied
3. 2nd coat application
4. Completed application

The repair was carried out in accordance with TCC-3. The two different coloured coats of Belzona 5811 were applied to avoid any pinholes or misses.
