# BELZONA INSITU RESTORATION OF SHAFT IN WASTEWATER PLANT

ID: 4047

Damaged shaft on rotary filter at wastewater station

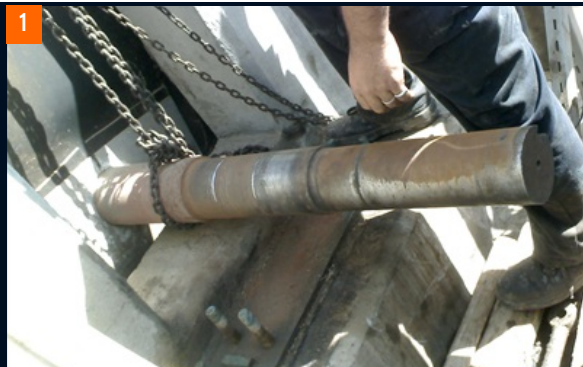
Shaft had become worn and needed insitu repair.

1. Worn shaft
2. Former treated with Belzona Release Agent
3. Application with split former in place
4. Former removed and shaft ready to be returned to service
