# CO2 ABSORPTION TOWER GETS BELZONA PROTECTION

CO2 Absorption Tower

Refinery - Argentina

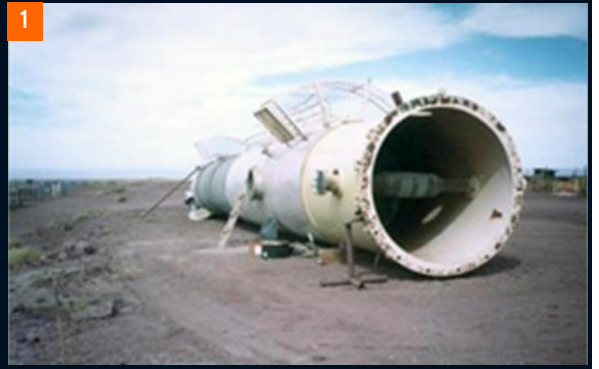
Severe corrosion on the interior of the tower due to the presence of MDEA and subsequent production of carbonic acid.

1. View of the tower before being taken into a shop for the application.
2. A high level of quality control was implemented during the surface preparation phase of the application, as well as with the rest of the job.
3. View of the final application. The Belzona 1391 was applied in two coats. Sandblasting was carried out in between the first and second coat.
