# BELZONA PROTECTS 4 NEW STERN TUBES

ID: 4053

Four newly fabricated stern tubes for naval vessel.

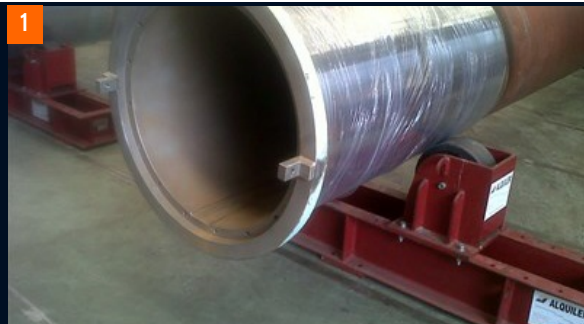
1. Stern tubes before the application
2. Internal surface of the stern tube grit blasted
3. First coat of Belzona 5811 applied and application of first coat of Belzona 1341 in process to the end section
4. Application completed
