# BELZONA PROTECTION INSIDE AND OUT!

ID: 406

Portable Acid Tanks for Oil Well Injection.

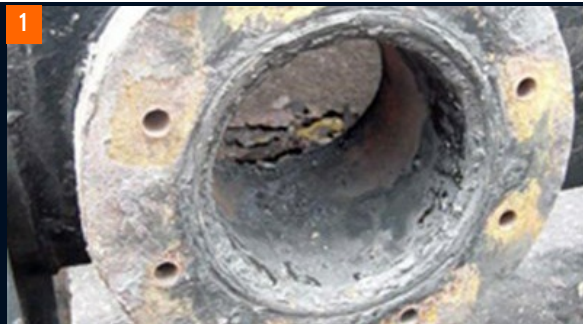
Internal corrosion due to contact with HCL (hydrochloric acid) 30-36% had caused severe corrosion on the walls, nozzles, fittings, etc. of the tanks. The exterior of the tanks had been damaged from atmospheric corrosion.

1. Extent of the corrosion due to the effects of the hydrochloric acid coupled with hydrocarbons and heat.
2. Nozzles coated with Belzona 4311 or Belzona 4341, depending on operating temperatures.
3. Pinhole detection being carried out over the Belzona coating system.
4. Exterior view of the tank coated on the outside with Belzona 6111/Belzona 5111.

Failure of vinyl ester coating forced customer to bring the tanks out of operation every 4-6 months. The Belzona solution allowed for the rebuilding of the damaged areas with Belzona® 1111. Depending on the operation temperatures of the tanks, either Belzona® 4311 or Belzona® 4341 was used as the coating material. Belzona® 6111/5111 was used on the exterior of the tanks.
