# AN UPLIFTING BELZONA SOLUTION

Relocation of two 22-ton riveted storage tanks.

Refinery - Brazil

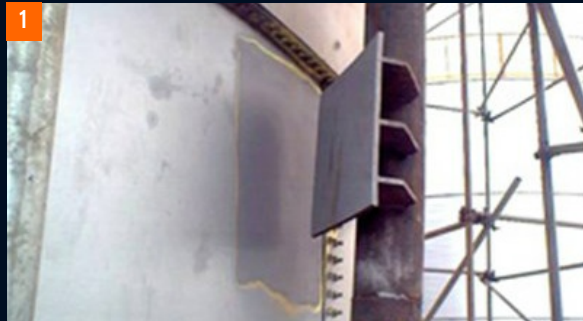
1. View of the metal pad to be bonded against the exterior wall of the tank.
2. View of the tanks, each with pads bonded in place, along with the upper support structure installed
3. One of the tanks being lifted with a crane
4. The tanks were moved 200 meters and 15Km respectively

The Belzona Technical Consultant, the end-user and an engineering company all became involved in devising the correct procedure with which to move the two tanks. Sixteen metal pads were bonded to each tank. A metal support structure was erected so as to prevent the walls from collapsing. Calculations of the mechanical properties of Belzona® 1111 revealed that by carrying out the application as planned that 420 tons could be supported. This presented a safety margin of approximately 1,170%.
