# BELZONA PROTECTS LARGE BUTTERFLY VALVE

ID: 408

Butterfly valve from cooling water system.

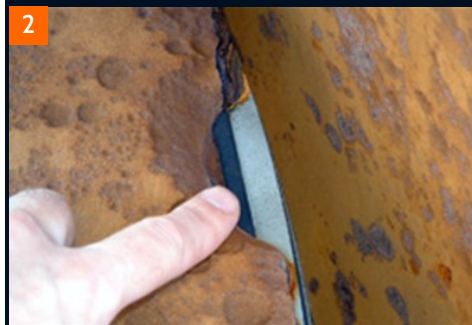
Severe erosion-corrosion on the body and particularly the valve disc.

1. Valve removed
2. Degree of erosion on the disc clearly evident
3. Application underway
4. Completed application
