# BELZONA PROTECTS COOLING WATER SPOOLS

ID: 410

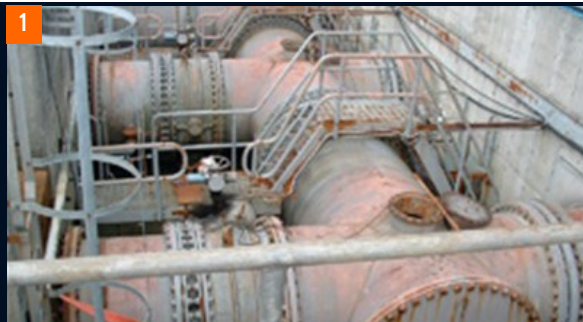
1. General view of the spools
2. Degree of original erosion clearly evident
3. Application underway
4. Completed application

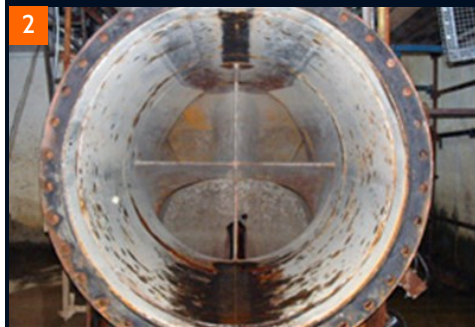
Previous coating was badly damaged allowing severe erosion-corrosion on pipework internals.

Some spools were so badly corroded that they had to be replaced or sleeved. The Belzona® 1341 coating will prevent future costly replacement becoming necessary.
