# BELZONA REPAIRS TO RUBBER LINED CONDENSER

ID: 411

Rubber lined water boxes of condensers.

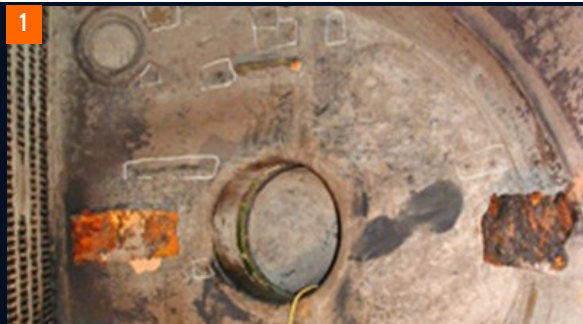
Spark testing of rubber lining highlighted several defects requiring repair.

1. Damaged areas of lining identified and marked ready for repair.
2. The repair area masked off to ensure application is kept within prepared area. Conditioner being applied.
3. One of the many local repairs completed.

Application was carried out in accordance with Belzona Know-How System Leaflet HEX-4. Spark testing identified defects which were then locally repaired.
