# BELZONA 5851 ON OFFSHORE PIPEWORK

Corrosion Under Insulation (CUI) on heating medium pipework.

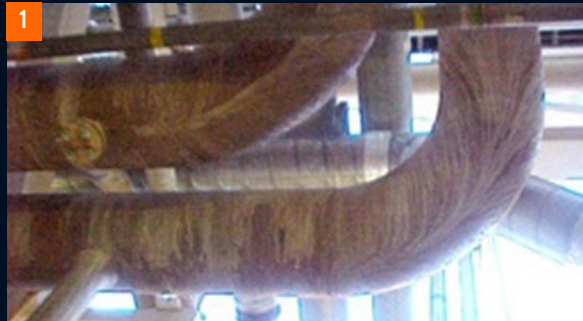
The presence of insulation around the heating medium pipework had led to some corrosion of the pipework over a period of time. During a routine inspection it was decided that applying Belzona® 5851 whilst the pipework remained in service represented the best option to prevent future corrosion.

1. Corrosion to heating medium pipework
2. Application of first coat of Belzona 5851
3. Completed application

The pipework was wet-blasted, allowed to dry and any residual aggregate brushed off. Some flash rusting was evident, and considered acceptable prior to application of two 250 micron coats of Belzona® 5851.
