# ABRASION PROTECTION FOR COAL CLASSIFIERS WITH BELZONA 1813

ID: 4121

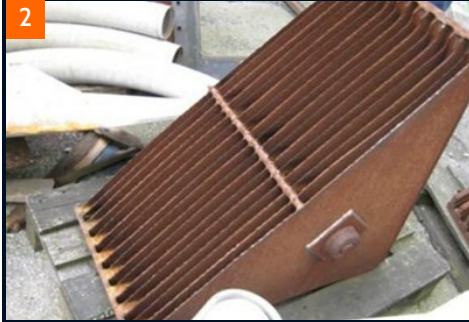
Extensive abrasion and wear

1. View of one of the coal dust classifiers
2. Close-up of a coal classifier showing the wear (top right)
3. Completed surface preparation
4. Application in progress

Initially, an ASR form was completed and reviewed by the technical team. Belzona® 1813 was applied by hand to the classifier edges and plate sides to a depth of approximately 100 mm.

The life of each classifier had been about six months, with service conditions including temperatures of up to 160°C (dry) and a throughput rate of approximately 5000m<sup>3</sup>/h per unit. Following the application of Belzona® 1813 on a trial basis, there were few signs of abrasion on the classifier deflector plates upon inspection 10 months later, in 2012. As a result, the customer plans to coat the old classifiers with Belzona® 1813 to prolong service life and other power stations within the group are investigating the use of this technology.
