# BELZONA SOLVES LEAKING SCHOOL ROOFS

ID: 4129

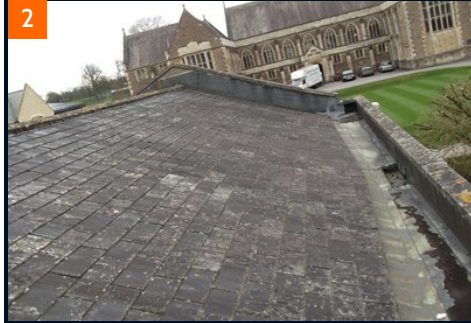
1. Asphalt replacement of lead flashing showing heavy UV degradation and breakdown
2. View of roof showing gutter and asphalt replacement of lead flashing
3. Belzona 3131 successfully applied to area of flashing where substrates are slate, asphalt & stone
4. Finished Belzona 3131 application to gutters and flashing.
