# INTERIOR COATING OF OIL STORAGE TANK WITH BELZONA

ID: 413

Interior coating of a 20,000-barrel crude oil storage tank.

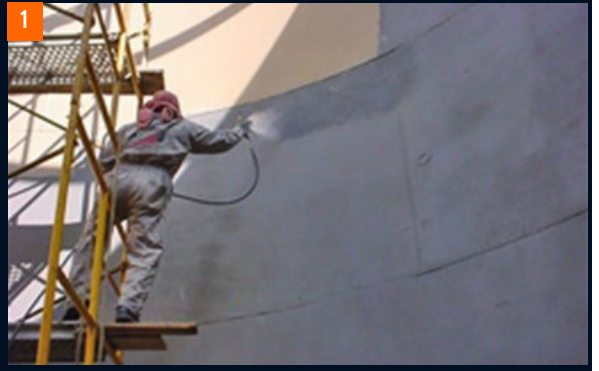
1. The application of Belzona 5811 was carried out using a single-pot airless system
2. High quality control was part of this application as is evident by the DFT (dry film thickness) readings that were taken
3. View of the two coat system applied. Low voltage holiday detection was carried out to rule out any pinholes on the coating before putting the tank back into service

The application of Belzona® 5811 was carried out using an airless spray system. As such, this large vessel was done at a fraction of the time when compared to conventional application methods. The selected Belzona coating system was chosen for its effectiveness against the anticipated corrosion from the acidic nature of the crude. In addition, it presented a cost-effective and environmentally-friendly product to apply.
