# BELZONA KEEPS DUST SUPPRESSION BOWSER IN SERVICE AT QUARRY

ID: 4130

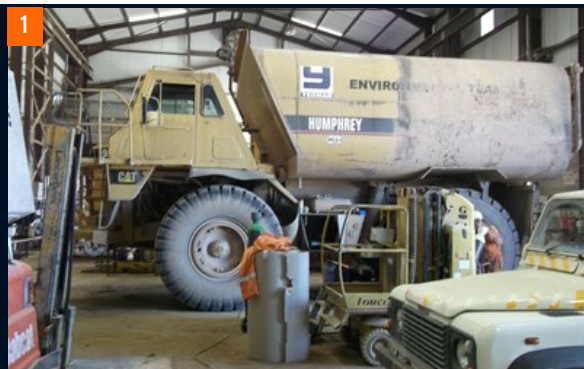
Quarry dust suppression bowser in workshop Damage and Corrosion to be repaired Initial application of Belzona 1111 Finished application. Cure accelerated by heat

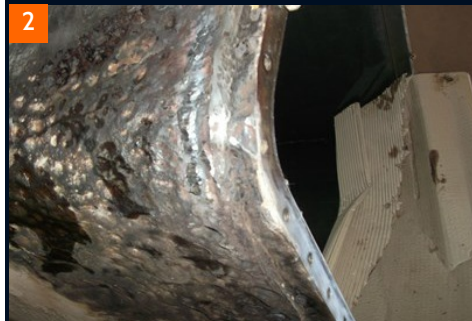
Dust suppression bowser had suffered damage and corrosion to its hydraulic tank causing leakage.

Traditional welding repair had failed to seal the tank. The customer required a fast cold curing solution to bring the bowser back into service.
