# COATING AND PROTECTION OF STORAGE TANK FOR PROCESSED WATER WITH BELZONA

ID: 414

Coating and protection of spent process water storage tank.

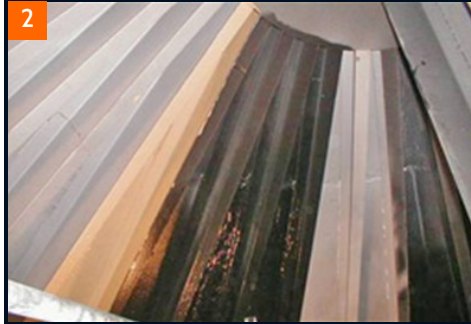
1. Upper conical portion of the tank being faired out with a Belzona 1000 Series product
2. Two-coat system of Belzona 5811 being applied to the top portion of the tank
3. View of the wall being coated with with Belzona 5811
4. Partial view of the interior of the tank after completion of the application
