# BELZONA BONDS SPADE RUDDER BEARING ON COASTER

ID: 4157

Spade rudder bearing on coastal ship.

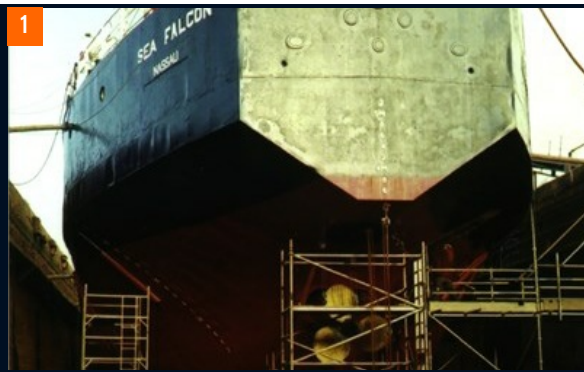
1. Vessel prepared for works in drydock
2. Top of bearing sealed using Belzona 1221
3. Injection of Belzona 1321 into the space
4. Completed works. The injection plugs are removed at the same time as the rudder is assembled.
