# BELZONA SEALS ROOF OVER PRODUCTION AREA

ID: 4158

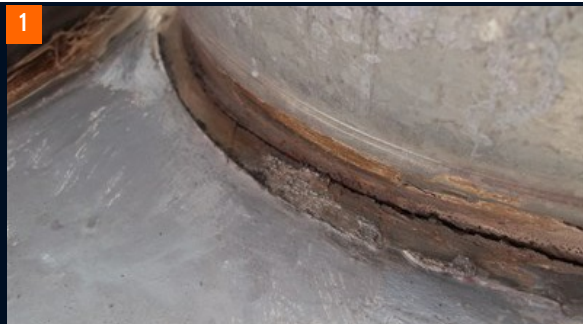
The effect of weather and UV caused rubber seals around ductwork penetrations to degrade allowing rainwater to leak directly into the production area creating disruption in production and safety issues.

1. Deteriorated joint
2. Belzona 2211 applied to seal gap
3. All joints sealed with Belzona Elastomer
4. Fully Reinforced Belzona 3111 system applied to give additional sealing and protection

Application was carried out in accordance with Belzona Know-How System Leaflet RPA-1 and 6. The joints were resealed with Belzona Elastomer, before applying a fully reinforced Belzona® 3111 Flexible Membrane system.
