# BELZONA INCREASES THE SERVICE LIFE OF SLUDGE MIXERS FROM NEW

ID: 417

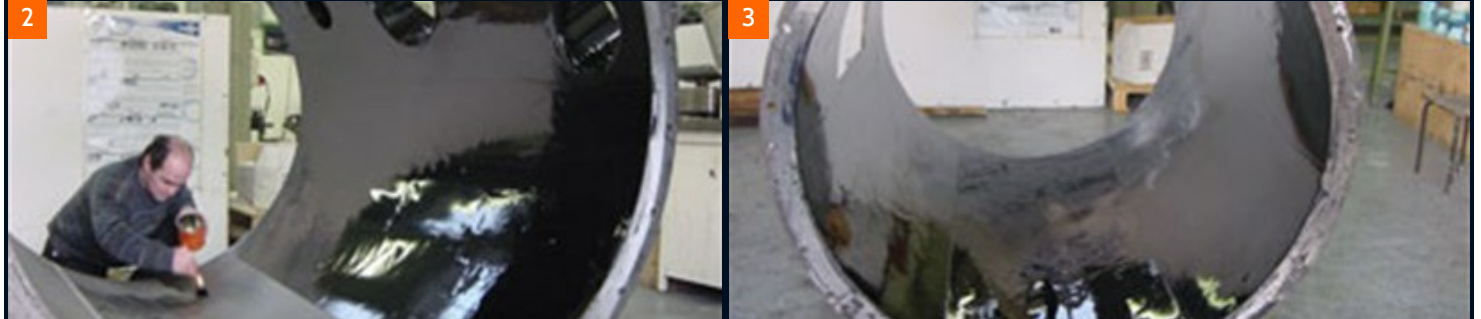
## PHOTOS

High level of erosion causes severe damage to the housing. The vessel manufacturer offered the customer an upgrade of the standard mixer which featured an erosion-resistant Belzona lining.

1. The mixer grit blasted and ready for application
2. Application of the Belzona 2121 in progress
3. The completed application

Application was carried out in accordance with Belzona Know-How System Leaflet TCC-3.

Belzona 2121 (D&A Hi-Coat Elastomer)
