# BELZONA CREATES SAFE ENTRANCE FOR WORKERS AND VISITORS

ID: 4175

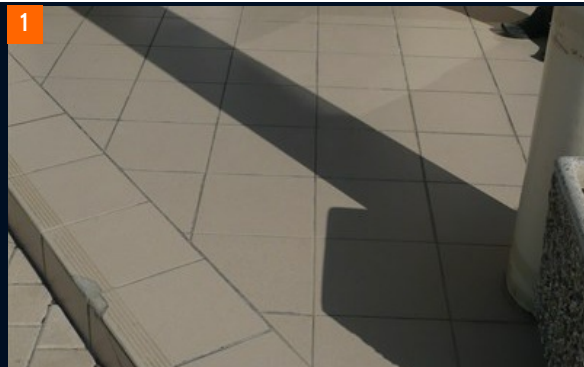
New quarry tiled floor at the entrance to the factory reception was extremely slippery when wet. This identified slip hazard had to be made good by the client.

1. New quarry tiles that are very slippery when wet
2. Application in progress - creation of pattern
3. Application finished
4. Application finished - close up shot

Belzona provided an acceptable and cost effective solution. Application was carried out late in the evening, in order not to disturb customers during his operating hours. In the morning the floor was ready. Belzona solution eliminated the trip hazard and provided durable and nice-looking non-slip system. The expensive alternative was to replace the quarry tiles.
