# BELZONA PROTECTS SLUG CATCHERS AGAINST EROSION AND CORROSION

ID: 418

Slug catchers destined for gas processing plant

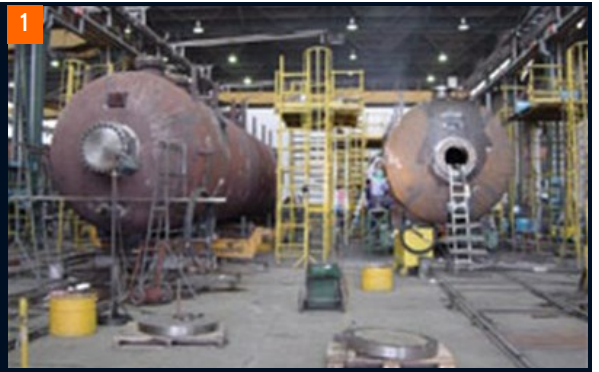
1. Two of the slug catchers ready for internal coating.
2. The Belzona 1391 being applied.
3. Sponge testing the Belzona 1391 to ensure no application defects were present in the coating.
