# CORRODED AMINE VESSEL SAVED BY BELZONA

ID: 4184

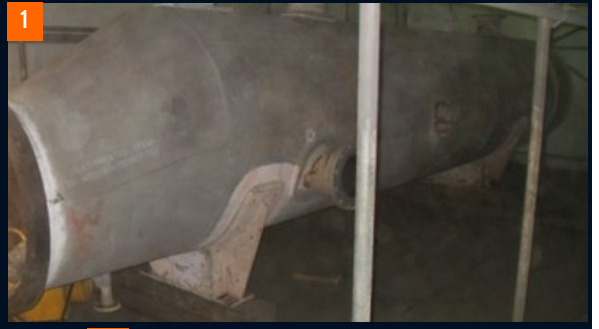
Picture 1 - The vessel in a contained environment for blasting. Picture 2 - Pitting and Corrosion Picture 3 - Belzona 1511 applied over pitting Picture 4 - Belzona 1591 Applied

The Vessel was grit blasted to SA 2.5 75 microns minimum. All brackets had their edges radius to 3mm. Belzona 1511 Super HT Metal was used to fill in the deep pitting that had occurred. A stripe coat of Belzona 1591 was placed around brackets. Two coats of 1591 was applied with a flash blast between coats. Remedial work was carried out where necessary.

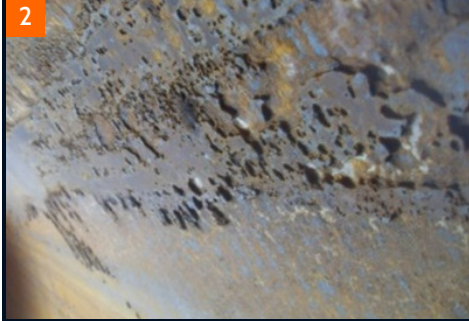
An Amine Boiler had suffered from the high temperatures with a high level of pitting and corrosion
