# BELZONA REPAIRS A CORRODED STORAGE TANK

ID: 4185

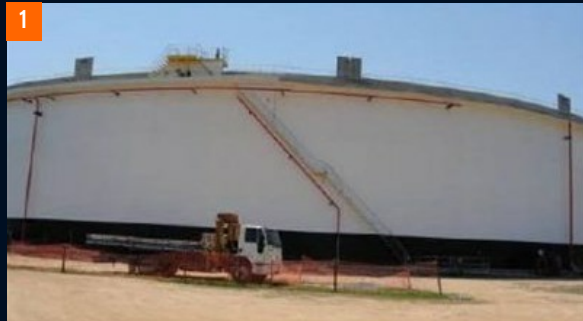
1. General view of the tank TQ-1010.
2. Top view of the tank.
3. Presence of corrosion.
4. Tank wall area during Belzona 1111 application.

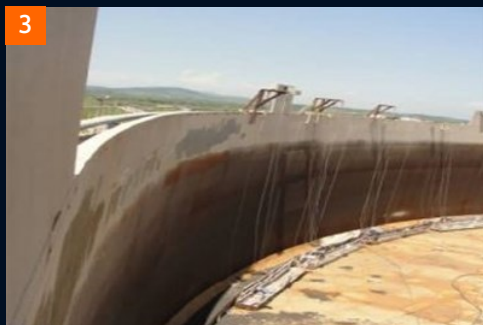
Exposure to oil and sea water at a maximum temperature of 75°C caused corrosion pitting and loss of wall thickness.

The application was carried out in accordance with Belzona Know-How System Leaflet TCC-1 as a guide. The surface was abrasive blasted and then Belzona 1111 was applied to repair the damaged areas.
