# SCOOP TRAM WITH DAMAGED PIN BEARING BACK IN SERVICE WITH BELZONA AFTER ONE DAY

ID: 4188

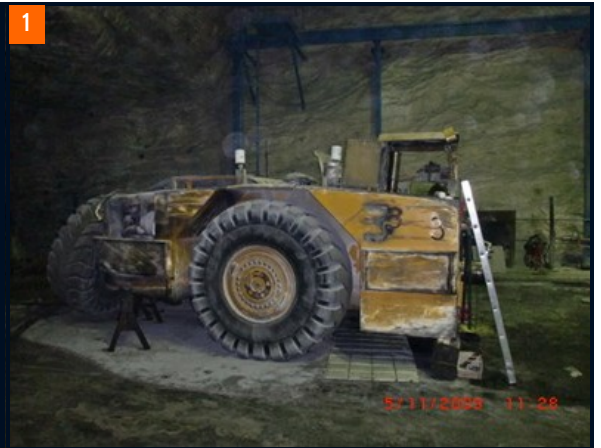
The severe corrosive and abrasive service conditions had led to metal loss on the articulated joint bearing pin, resulting in a relatively short life of the component.

Scoop tram before application Injection of the Belzona material Completed application After reassembly of the bearing

Dismantling the pin housing for replacement would have been very time consuming and costly as the entire backing plate would have had to be detached. The Belzona forming technique not only allowed for the repairs to be completed in-situ after just one day but also significantly extended the life expectancy of the scoop tram bearing pin.
