# CLASSIC PIN-HOUSING REPAIR WITH BELZONA

ID: 419

Bush housing on excavator shovel

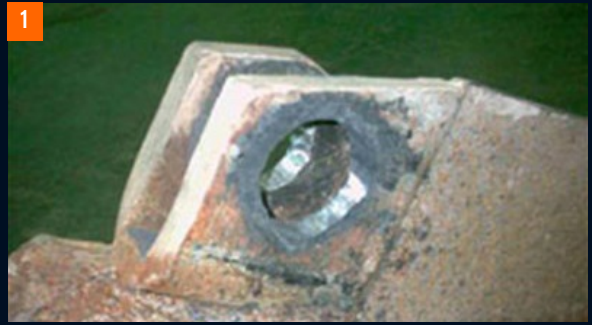
Fretting and wear caused ovality of the bush housing due to the high forces transmitted through the pins.

The damaged housing Belzona 1111 applied and the new bushes located in the correct place by a pin between the housings The completed repair
