# BELZONA REBUILDS DAMAGED SLIDING FACE OF MILLING MACHINE

ID: 4190

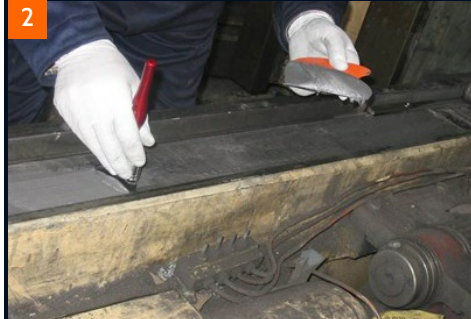
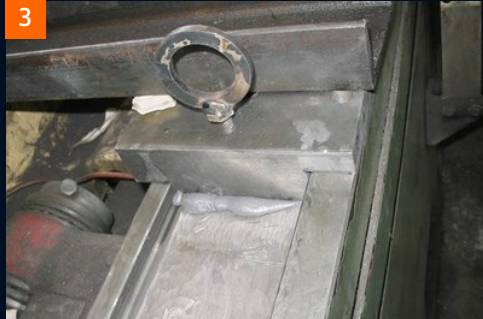
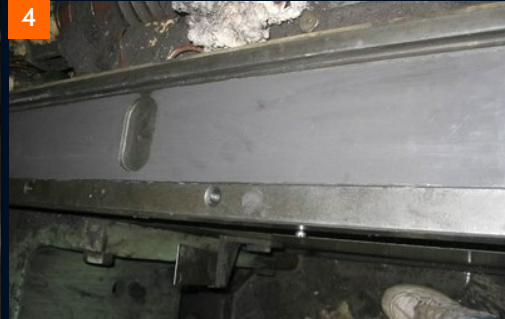
The horizontal mating face of the mill was damaged due to impact. Therefore this had to be rebuilt in order for the equipment to operate correctly.

1. After surface preparation
2. Product being applied
3. Former being used.
4. Finished repair

The surface was roughened by using an angle grinder. Belzona 1111 was applied in excess before a specially fabricated was used to restore it to the original dimensions.
