# BELZONA REBUILDS AND PROTECTS PUMP CASING AND IMPELLER

ID: 4192

Pump casing and impeller

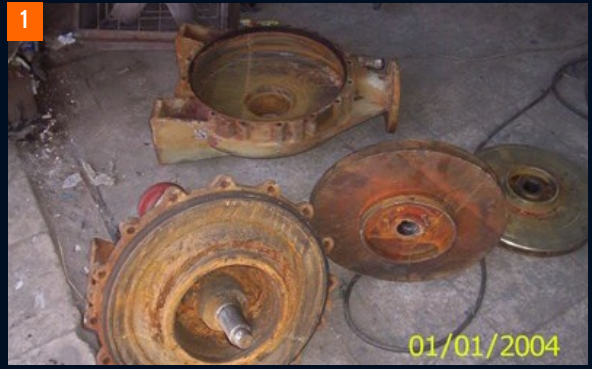
Pump casing and impeller had become damaged due to erosion-corrosion

1. Original Damage
2. Belzona 1311 completed application
3. Belzona 1321 application
4. Completed application
