# BELZONA RESTORES CORRODED HEAT EXCHANGER

ID: 4196

Tube Sheet from chiller unit

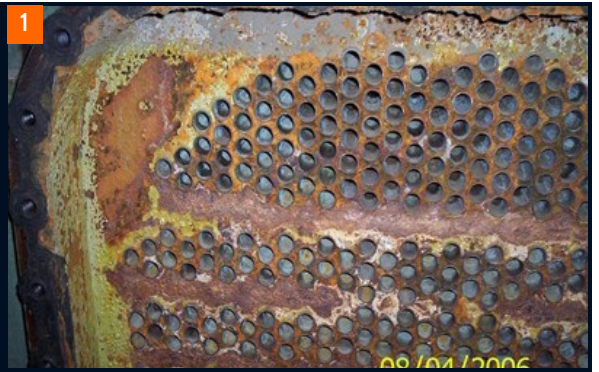
The tube sheet was badly corroded. Particularly deep erosion on tube sheet around the tubes.

1. The original corrosion damage
2. After Surface Preparation
3. Belzona 1311 application
4. Completed Belzona 1341 application
