# BELZONA RESTORES TUBE SHEET PROTECTION

ID: 4197

condenser Tube Sheet

Power station, Cairo, Egypt

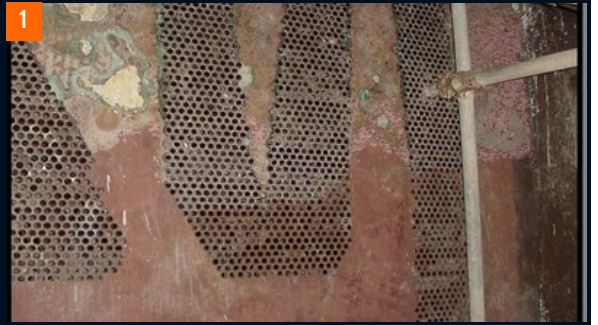
Original coating on tube sheet had failed. Replacement required to prevent future corrosion.

1. Damaged original coating
2. After surface preparation
3. First coat of Belzona 1321 applied
4. Second coat of Belzona 1321 applied
