# BELZONA RESTORES PERFORATED PROFILE OF COUCH ROLL

ID: 42

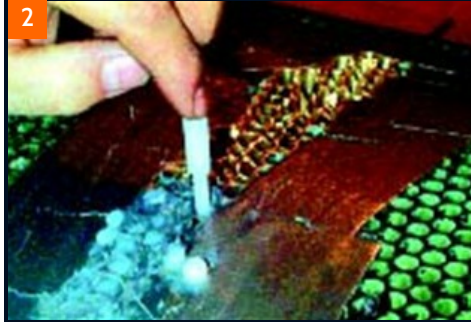
A mill wright's tool was introduced onto the couch roll and caused damage to a foot long section of the roll.

1. Rebuilding the foot long damage area with Belzona 1111 (Super Metal)
2. Inserting the tapered nylon plugs
3. Grinding the plugs as well as the Belzona 1111 (Super Metal) flush with the roll
4. Finished repair with the roll profile restored
