# SOAP POWDER CAN'T WASH BELZONA AWAY!

ID: 420

Soap Mixer

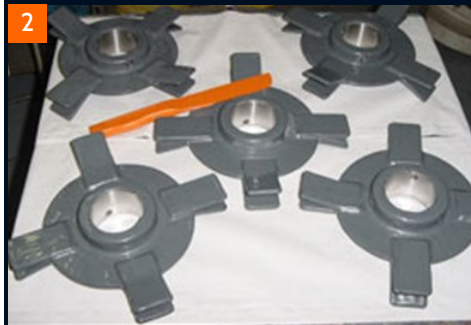
Corrosion from the soap powder and water mixture damages the housing and rotating elements of the mixer.

1. The mixer as it arrives
2. The coated rotating elements
3. The mixer end covers coated
4. The mixer body coated
