# BELZONA REBUILDS AND PROTECTS CAVITATED FAN VANES

ID: 4202

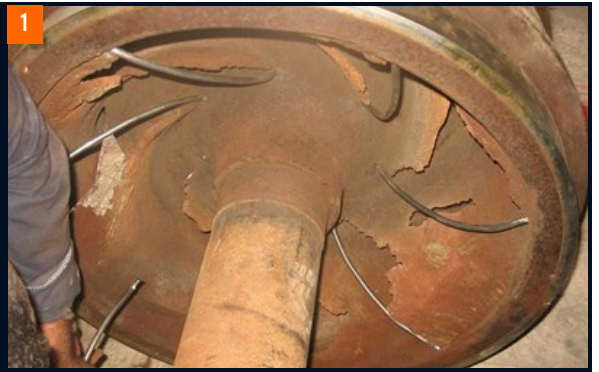
The fan blades were suffering from the effects of cavitation damage.

1. Damaged Fan Blades
2. Belzona 1311 application
3. First coat application of Belzona 1321
4. Second coat application of Belzona 1321
