# BELZONA PROTECTS PUMP PLINTH

ID: 422

Pump Plinth

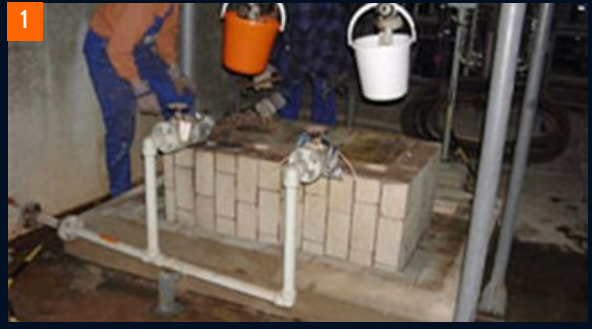
98% Sulphuric acid leaking from the pump had damaged the grout between the acid resistant tiles and attacked the concrete beneath.

1. The damaged pump plinth
2. Rebuilt with Belzona 4111
3. And coated with Belzona 4341
