# BELZONA 3211 (LAGSEAL) IN TOUGH ENVIRONMENT - 2ND TIME AROUND

Coating on insulated caustic storage tank

Power plant in Texas, USA

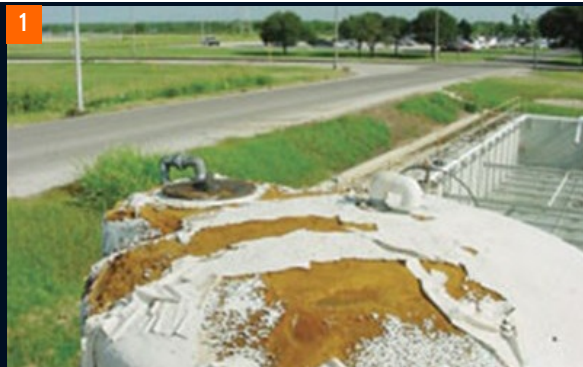
1. View from acid tank
2. Surface preparation
3. Belzona 3211 applied
