# BELZONA IN-SITU REPAIRS TO PORCELAIN INSULATORS

ID: 4233

A brand new porcelain shed had been damaged whilst in transit to the Substation which required an immediate in-situ repair.

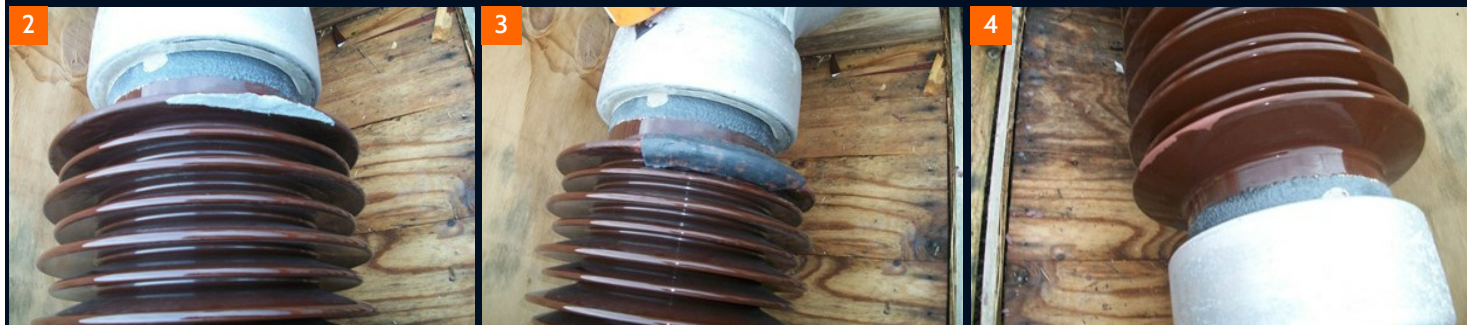
1. Damaged porcelain shed in transport crate
2. Shed edge wet out with Belzona 1221
3. Belzona Elastomer former containing Belzona 8112
4. Completed repair

The porcelain insulator rebuild repair was completed in accordance with the Belzona Know-How System Leaflet VPF16.

Belzona 1221 (Super E-Metal)  
Belzona 2211 (MP Hi-Build Elastomer)  
Belzona 8112
