# BELZONA REBUILDS CRACKS IN SWIMMING POOL BASIN

ID: 4244

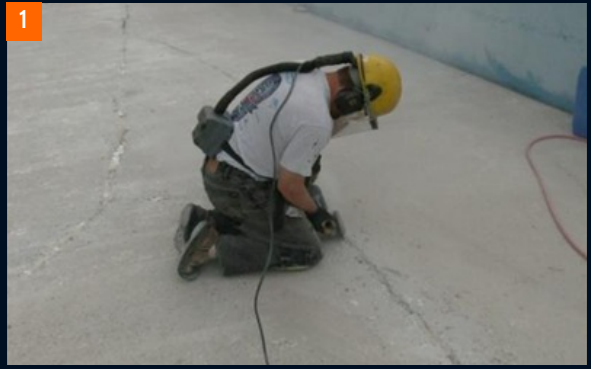
There were more than 500 lineal feet of cracks in the pool basin. These had been sealed over the years using various repair materials, some successful others not so successful.

1. Removing old sealants
2. The prepared joints ready to be re-built
3. Cracks filled and levelled with Belzona 4111

Application was carried out in accordance with Belzona Know-How System Leaflet FPA-1. The cracks were "V" cut with a special diamond concrete grinding disc to remove all the old sealing and repair materials exposing firm rough concrete. The cracks up to 3/4" deep were then conditioned and filled flush with Belzona® 4111.
