# BELZONA REPLACES HOT TUB EXPANSION JOINTS

ID: 4250

Hot pool within swimming pool complex.

Municipal swimming pool, Coquitlam, British Columbia

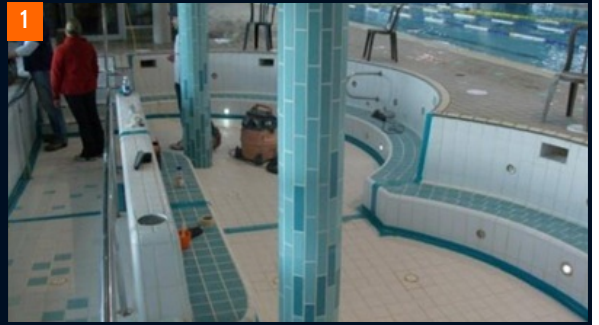
1. Preparation underway
2. All horizontal joints are filled with Belzona 2221 and vertical joints with Belzona 2211
3. The masking tape is removed after allowing the product to set up for about 30 minutes

Application was carried out in accordance with Belzona Know-How System Leaflet FPA-6. The old original grouting material was cut out and the joints allowed to dry out overnight before the surfaces were ground, vacuumed and then masked off to ensure a neat and tidy joint after injecting Belzona Elastomer into joints.
