# BELZONA EXPANSION JOINTS REFURBISHED AFTER 5 YEARS SERVICE

ID: 4251

Municipal swimming pool, Victoria, British Columbia

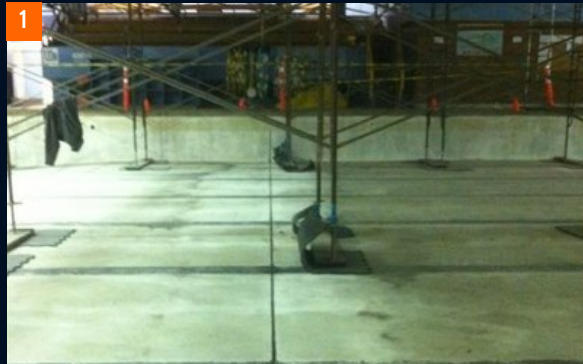
Over a period of time the exposed surface of the Belzona Elastomer oxidizes allowing it to slowly erode with the water movement.

1. Some of the Belzona expansion joints after 5 years of service had eroded to below the level of the pool tiles and needed to be "topped up"
2. The old joints were cleaned with a wire wheel to remove all oxidation before being Conditioned
3. Joints refurbished with Belzona 2221
