# BELZONA IN-SITU REPAIR OF SHAFT FROM PRE-HEATER FAN

ID: 426

Cement pre-heater fan

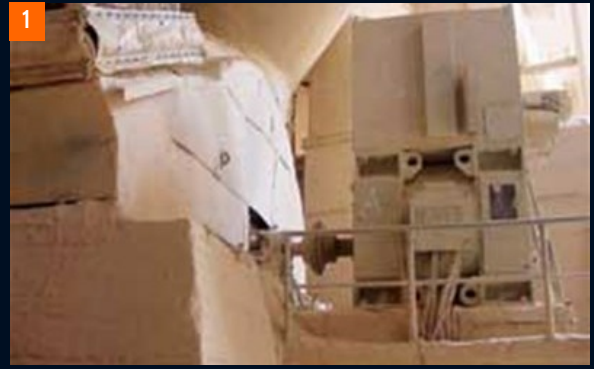
1. General view of the pre-heater fan housing
2. The damaged shaft
3. The prepared split former
4. Completed application after removing former

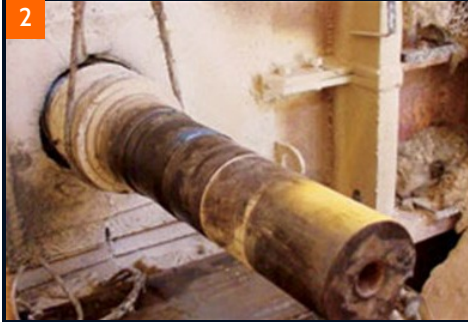
Worn shaft due to bearing seizure.
