# BELZONA REFURBISHES HEAT EXCHANGER ON CRUISE LINER

ID: 4263

Large seawater-cooled chiller, providing onboard comfort cooling.

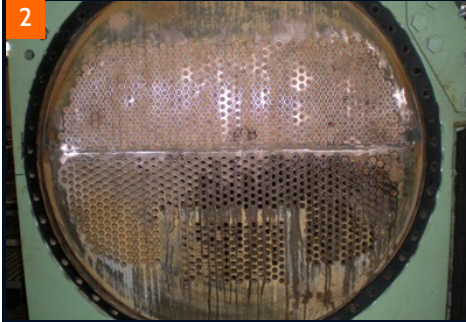
The heat exchanger tube sheet was found to be corroded, with isolated pitting in the division bar seal face.

1. The luxury cruise liner
2. Damaged tube face
3. Application of Belzona 1321
4. Completed application

The application was carried out in accordance with Belzona Know-How System Leaflets HEX-1 and HEX-3. corrosion pitting was rebuilt with Belzona® 1121 before applying Belzona® 1321 for overall corrosion protection.
