# BELZONA REFURBISHMENT OF COOLING WATER PUMP DIFFUSER

ID: 427

Diffuser and bell-mouth from main cooling water lift pump.

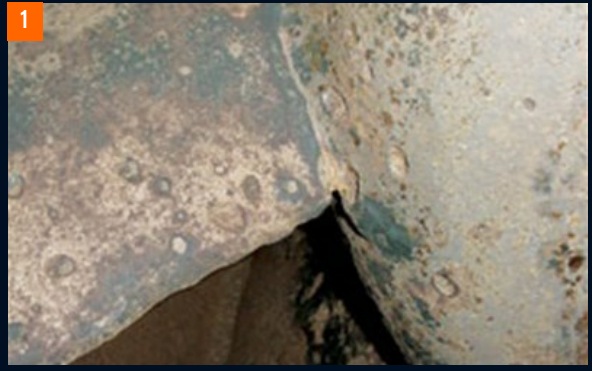
Severe erosion-corrosion.

1. Severity of erosion clearly evident
2. Surface preparation by grit blasting
3. Erosion rebuilt using Belzona 1311
4. Coating with Belzona 1341 underway
