# BELZONA REPAIRS CEMENT BALL MILL

Ball mill used to grind ingredients for cement production.

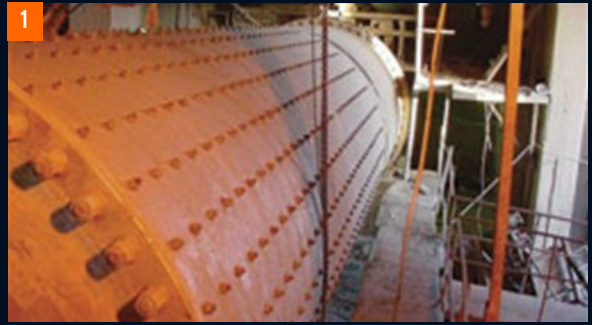
1. General view of the ball mill
2. Damage to mill barrel being indicated
3. Application of Belzona completed.  
Wear plates will be bolted in over the repair.

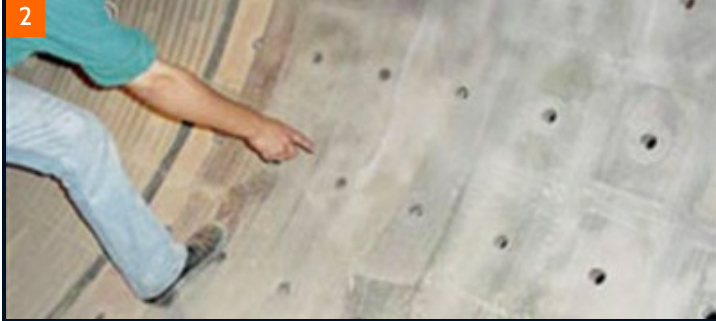
Wear had occurred on the housing due to breakage of lining tiles which leads to direct impact of milling balls with barrel.

Belzona® 1111 restored the original dimensions using a simple former in a fraction of both time and cost. A conventional approach to repairing this problem - welding - was not an option due to the large size and difficulty of machining.
