# BELZONA REPAIR STILL IN PLACE AFTER NINE YEARS & MILLIONS OF PASSEOVERS

ID: 429

Big pothole in busy concrete interstate highway.

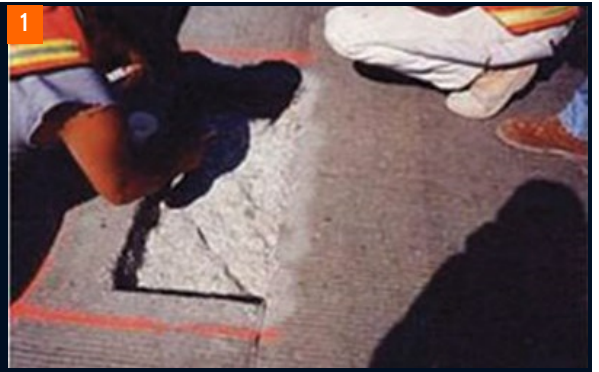
1. Final stages of surface preparation
2. Belzona 4131 down; ready for next phase
3. Belzona 4111 applied
4. External heat apparatus to speed up the lane opening

This nine-year-old application is on the busiest stretch of interstate in the state of Missouri - linking St. Louis with Kansas City. The ragged edges and spalled concrete were cut out. Belzona® 4131 was used to fill in the hole, topped off with 1/4"-inch of Belzona® 4111. The application area was then covered with concrete blankets and heated with a gas-fired portable heater. External heat was applied for 50 minutes at 180°F, allowing the lane to open less than four hours later. It's still there today.
